September 1988

**AERIAL PHOTOGRAPHIC PROPERTY STUDY
LOCKHEED SHIPBUILDING AND CONSTRUCTION COMPANY
SEATTLE, WASHINGTON: 1936 - 1985**

The report provides temporal views of the facility of Lockheed Shipbuilding Yard 1 using aerial photographs taken over the area from 1936 through 1985.

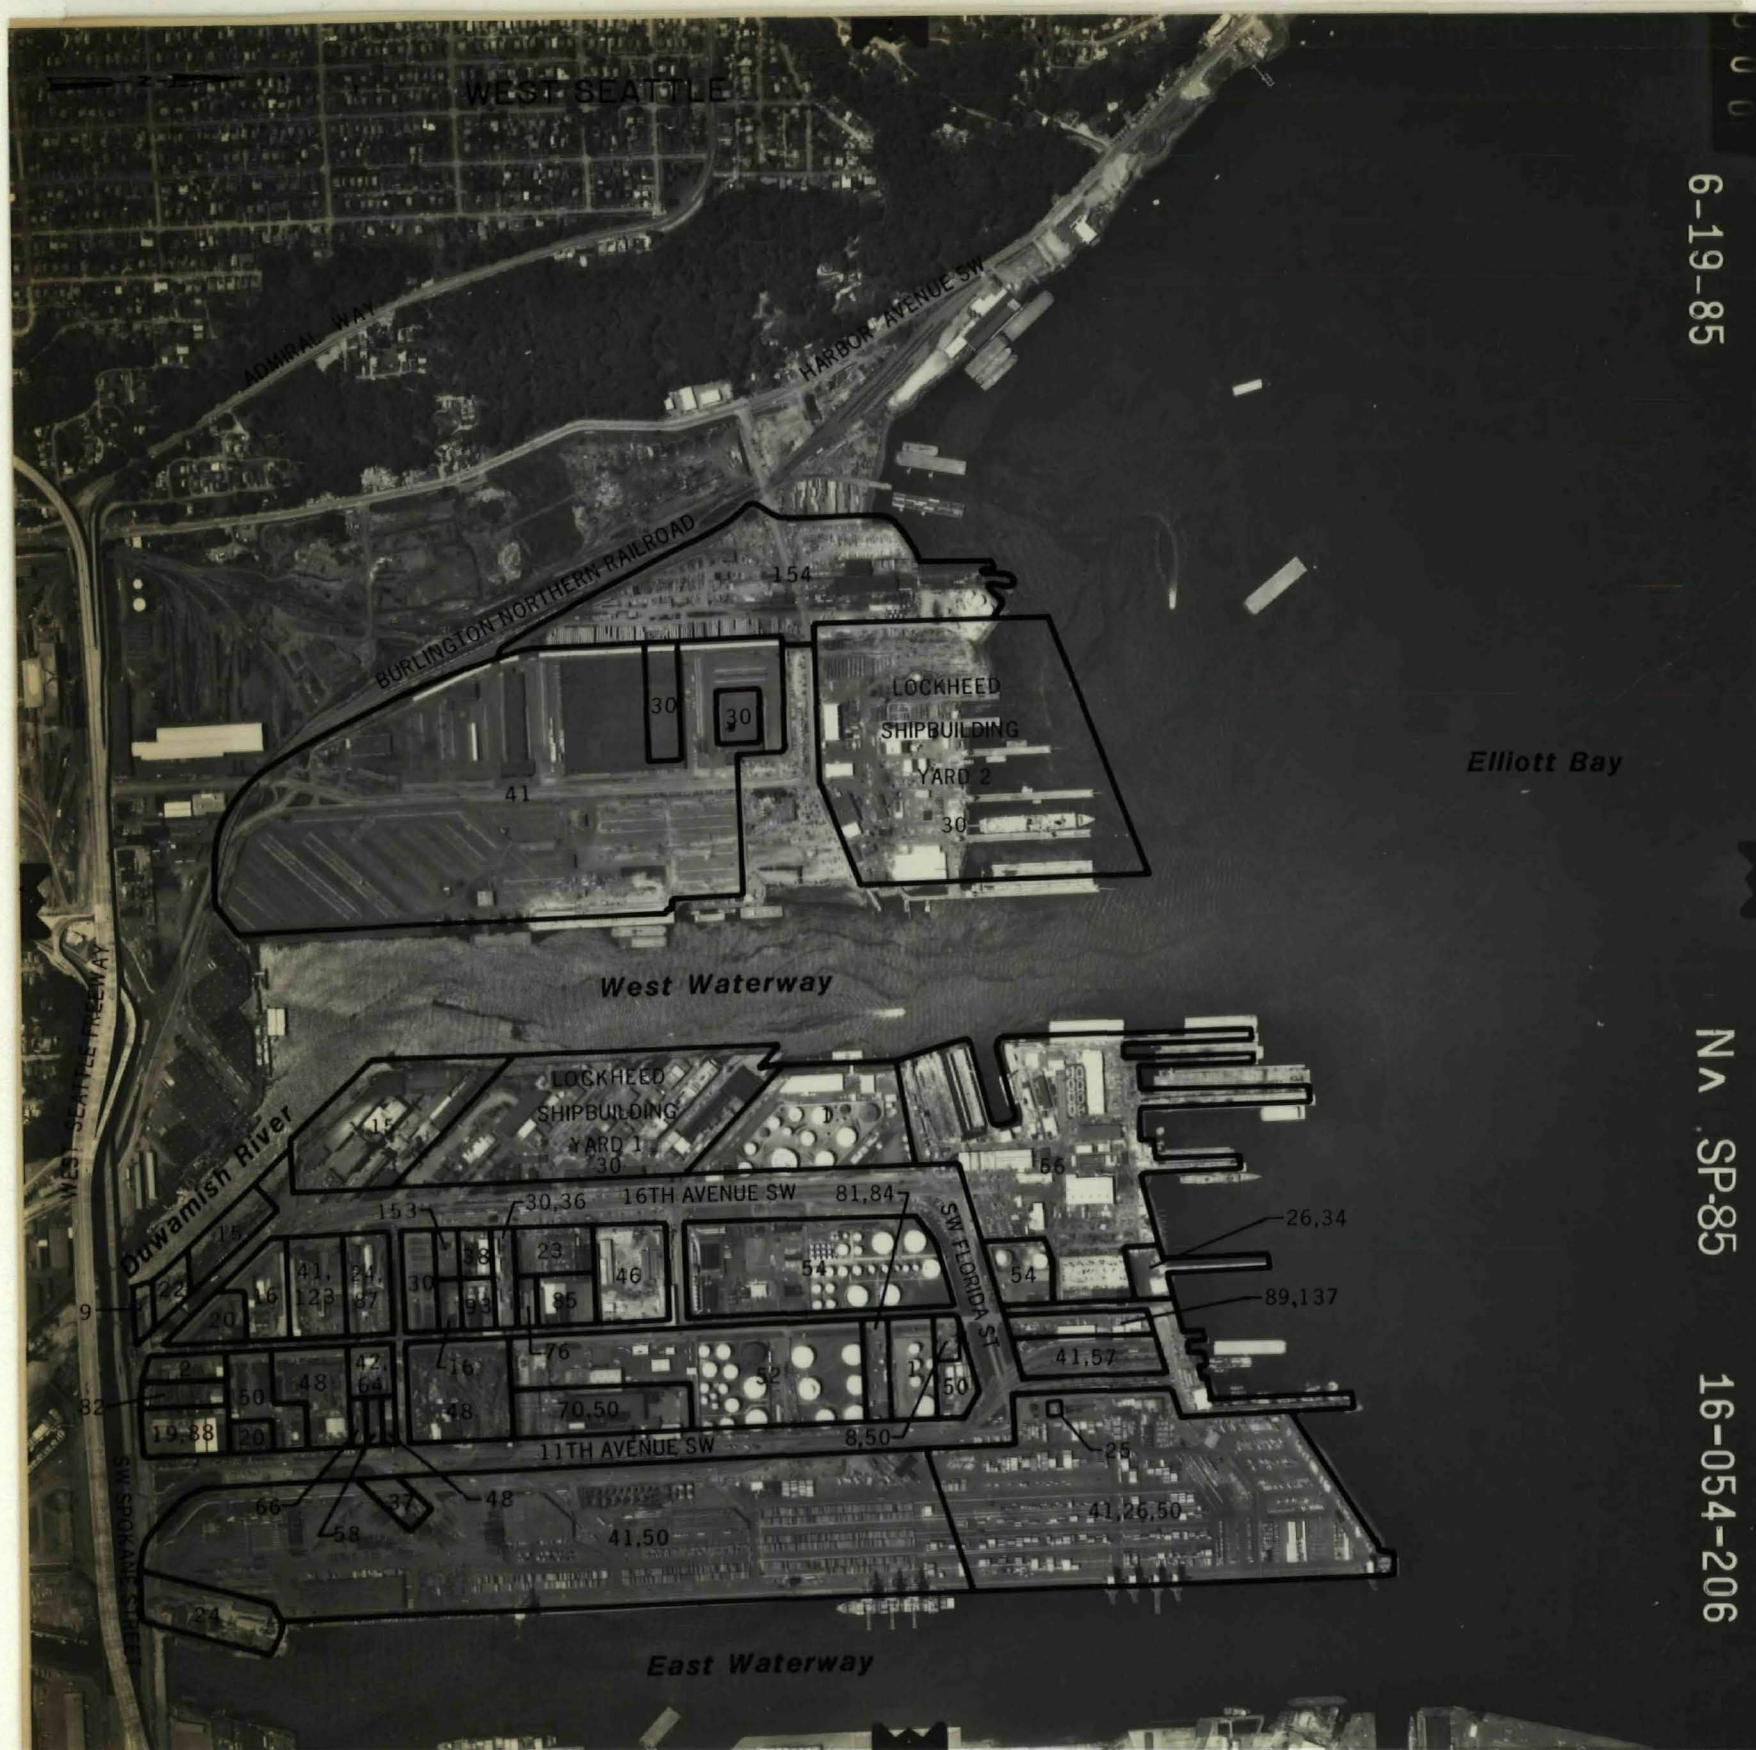
Photograph 3-1. Major facilities and Land Owners on Harbor Island.
Approximate scale, 1 inch equals 1000 feet.

Table 1 lists a number of major land ownerships and facilities on Harbor Island. This list is keyed to Photograph 3-1, which shows the location of these facilities in relation to Shipyard 1. The only surface water associated with Harbor Island is the surrounding (receiving) waters of the Duwamish River (West Waterway) and Elliott Bay. Although ground water and other hydrogeologic factors on Harbor Island have only recently begun to be characterized, the situation is expected to be complex because the site is a dredge and fill island at the outlet of a major river. Variability in the thickness, compaction, and composition of fill material comprising the island complicates hydrogeologic characterization. Tidal effects and river flow dynamics also are expected to influence the ground-water system significantly.

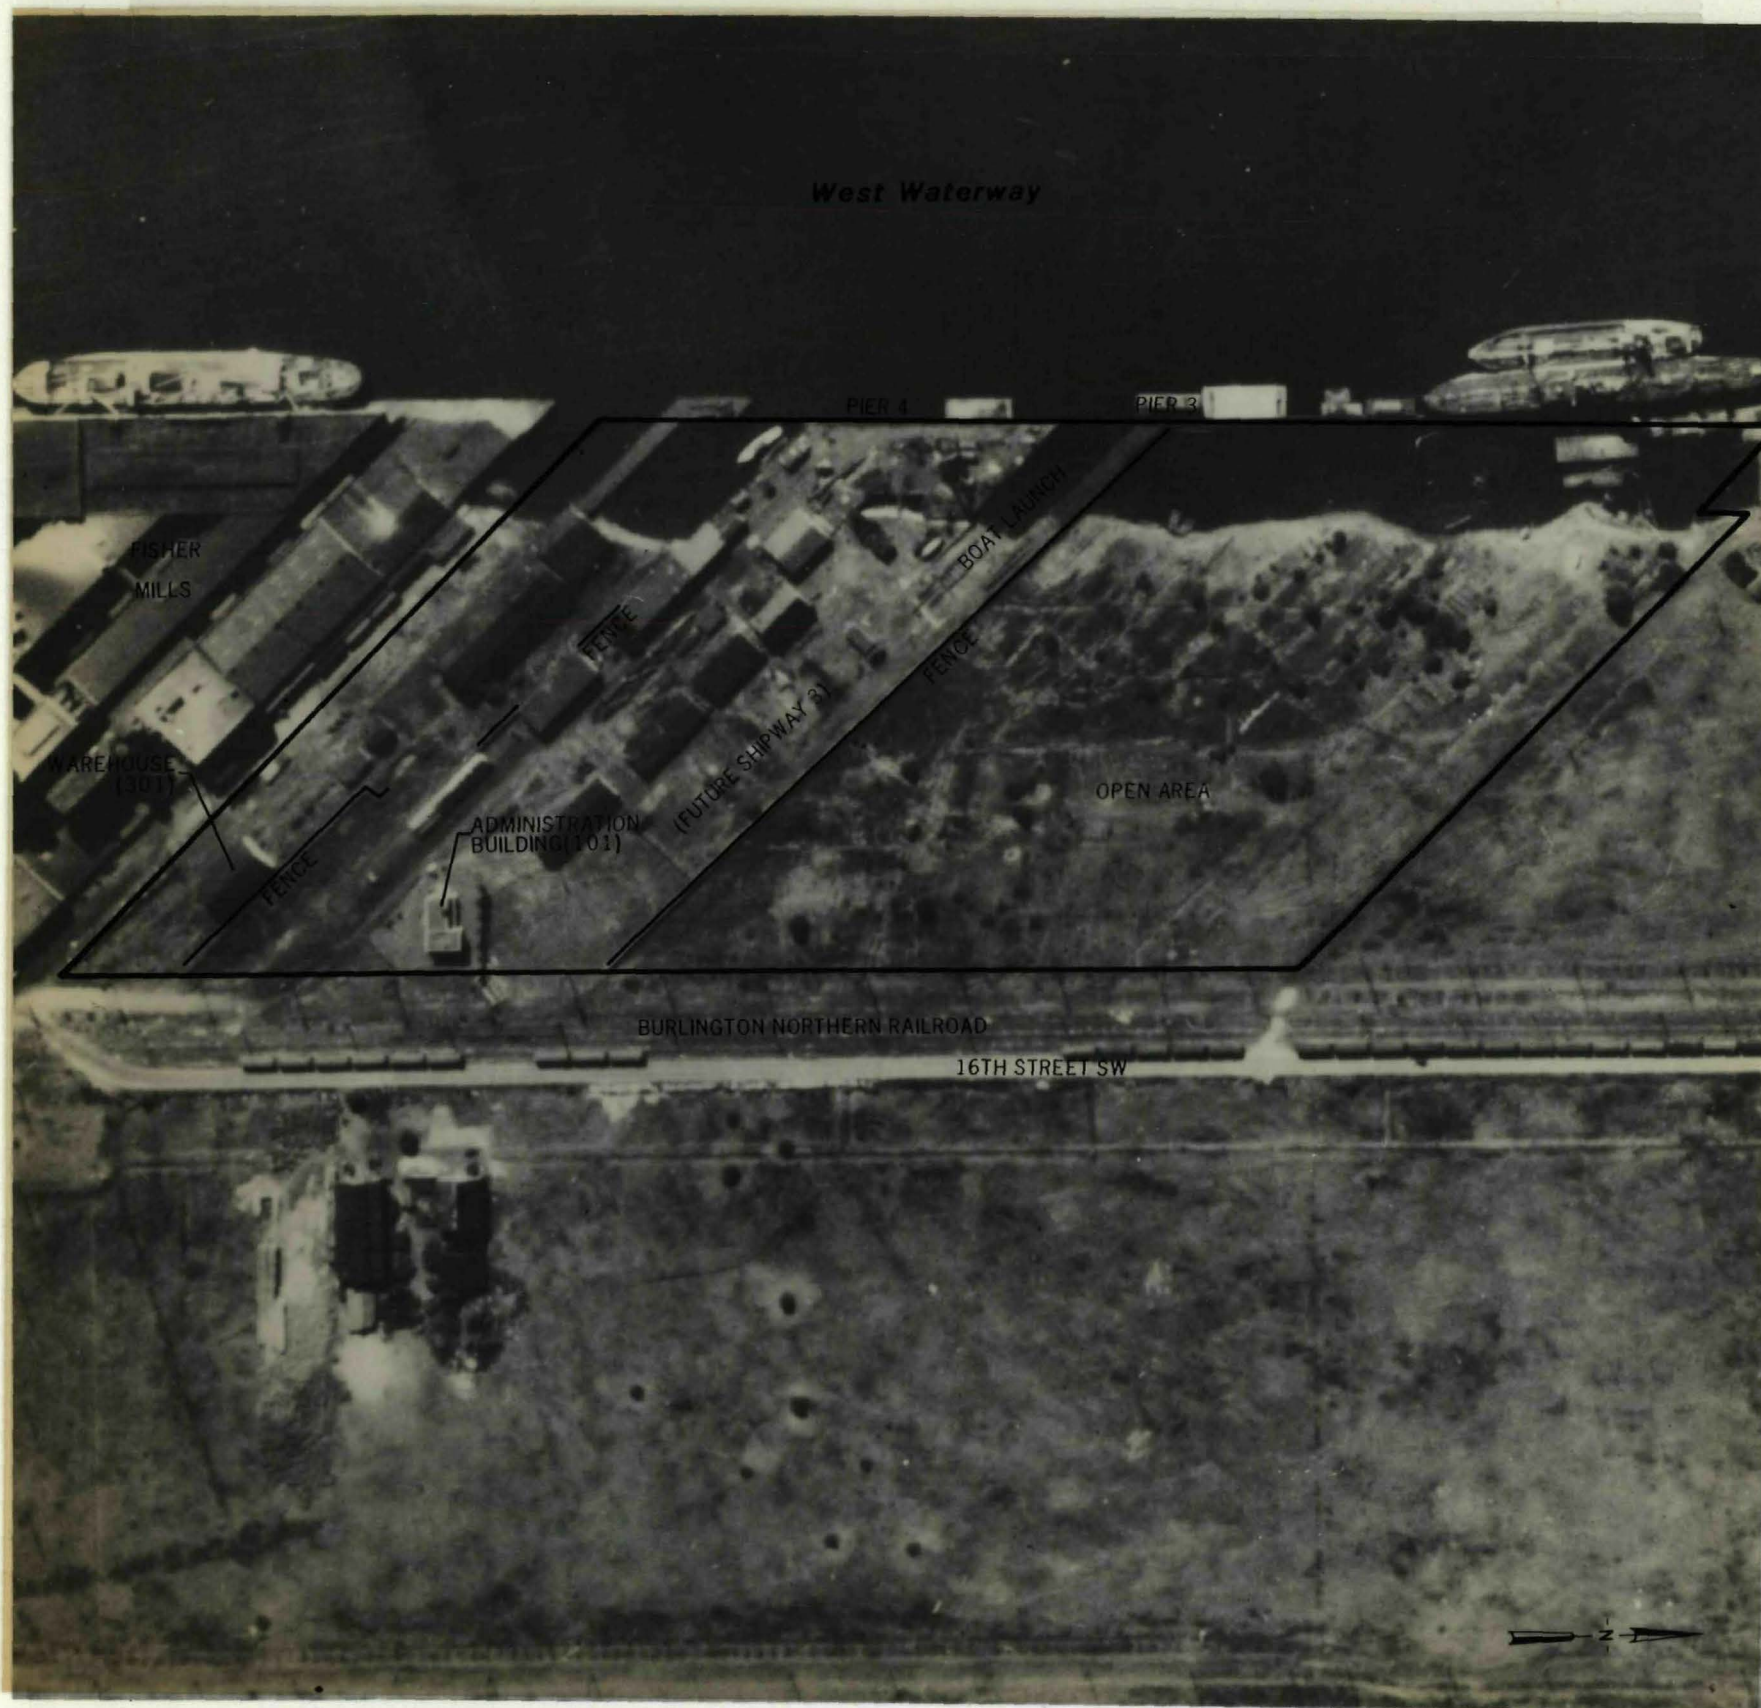
Photograph 7-1. Shipyard 1: 1936. Approximate Scale, 1 inch equals 250 feet.

The earliest available aerial photograph taken over the future site of the Yard 1 facility shows that in the mid-1930's it was partitioned by a fence into an inactive open area on the north and an active facility to the south. Facilities that can be spatially correlate to present day development include Piers 3 and 4, administration building (Building 101), a warehouse (Building 301), and a boat launch (Shipway 3).

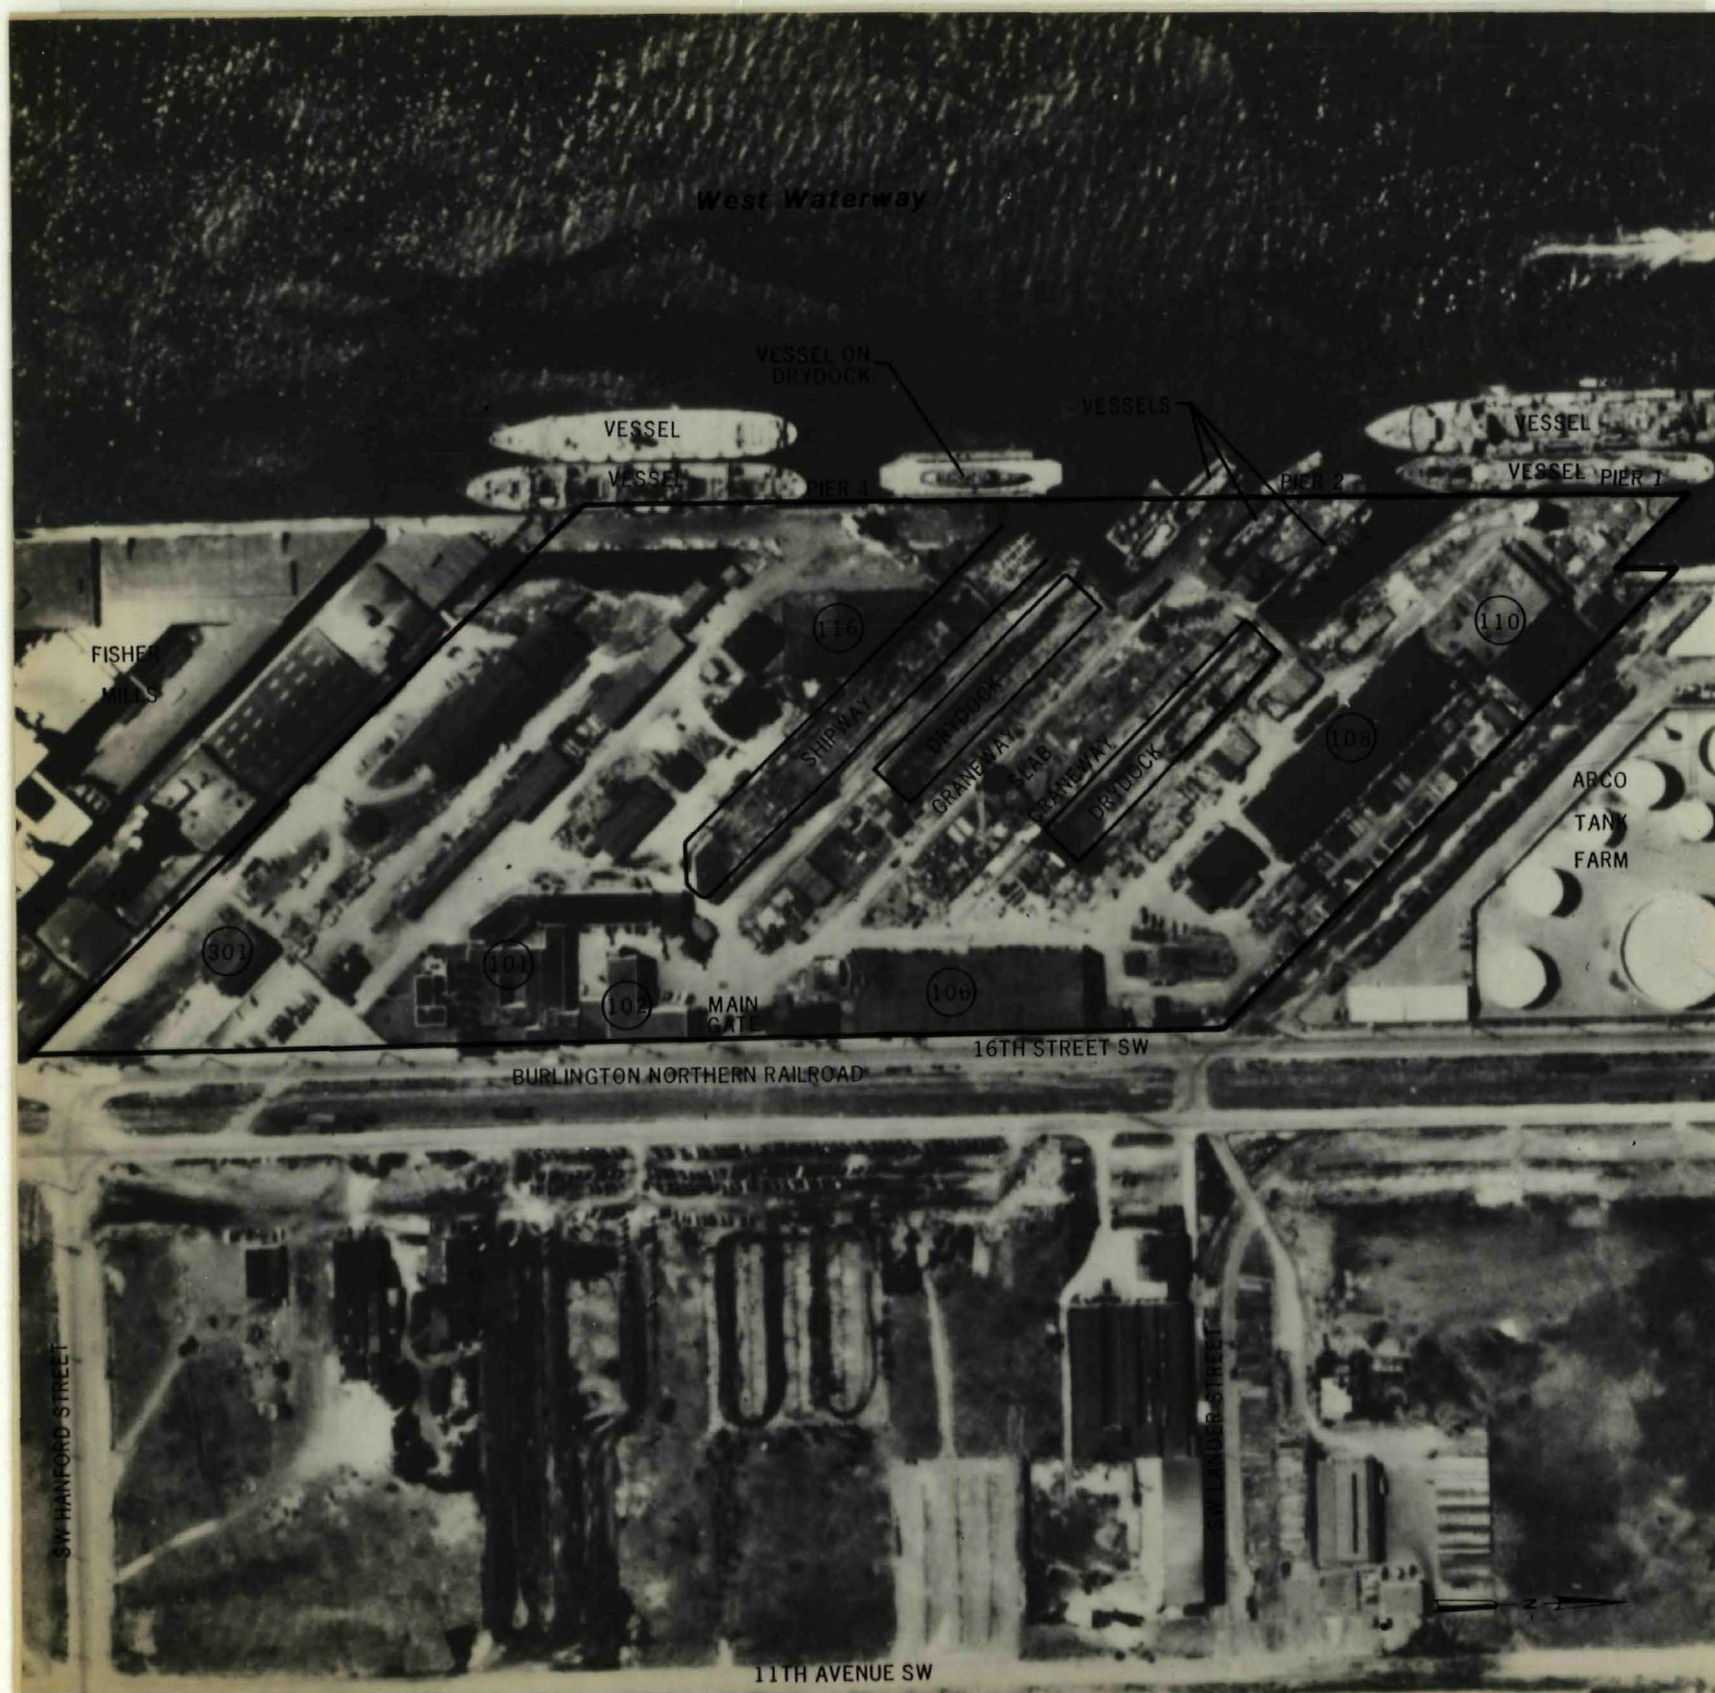
Photograph 7-2. Shipyard 1: June 17, 1946. Approximate Scale, 1 inch equals 250 feet.

Major construction of the Yard 1 facilities on Harbor Island began in the spring of 1940 and was completed by mid-1941. Several of the main buildings occupying the site today were in place before 1946. Although not all these buildings may have served the function they do today, they have been identified on the photograph with the code that represents the use or purpose of each building at the present time to facilitate comparison with the entire historical photographic sequence. Present in 1946 were facilities that included:

- Building 101 and 102 (Administration)
- Building 106 (Plate Shop)
- Building 108 (Mold Loft)
- Building 110 (Machine Shop)
- Building 116 (Warehouse)
- Building 301 (Warehouse)

Pier 1 existed in its present day location and configuration. Pier 2 consisted of two pier structures (that would later be combined into one pier by a bulkhead). Pier 3 did not exist. Pier 4 existed in its present day location and form.

Also on site were a shipway, two dry docks, two craneways, and one slab. The shipway occupied present day Shipway 3; the southernmost dry dock occupied present day Shipway 4A; the slab, present day Slab 3; and the northernmost dry dock, present day Shipway 1.

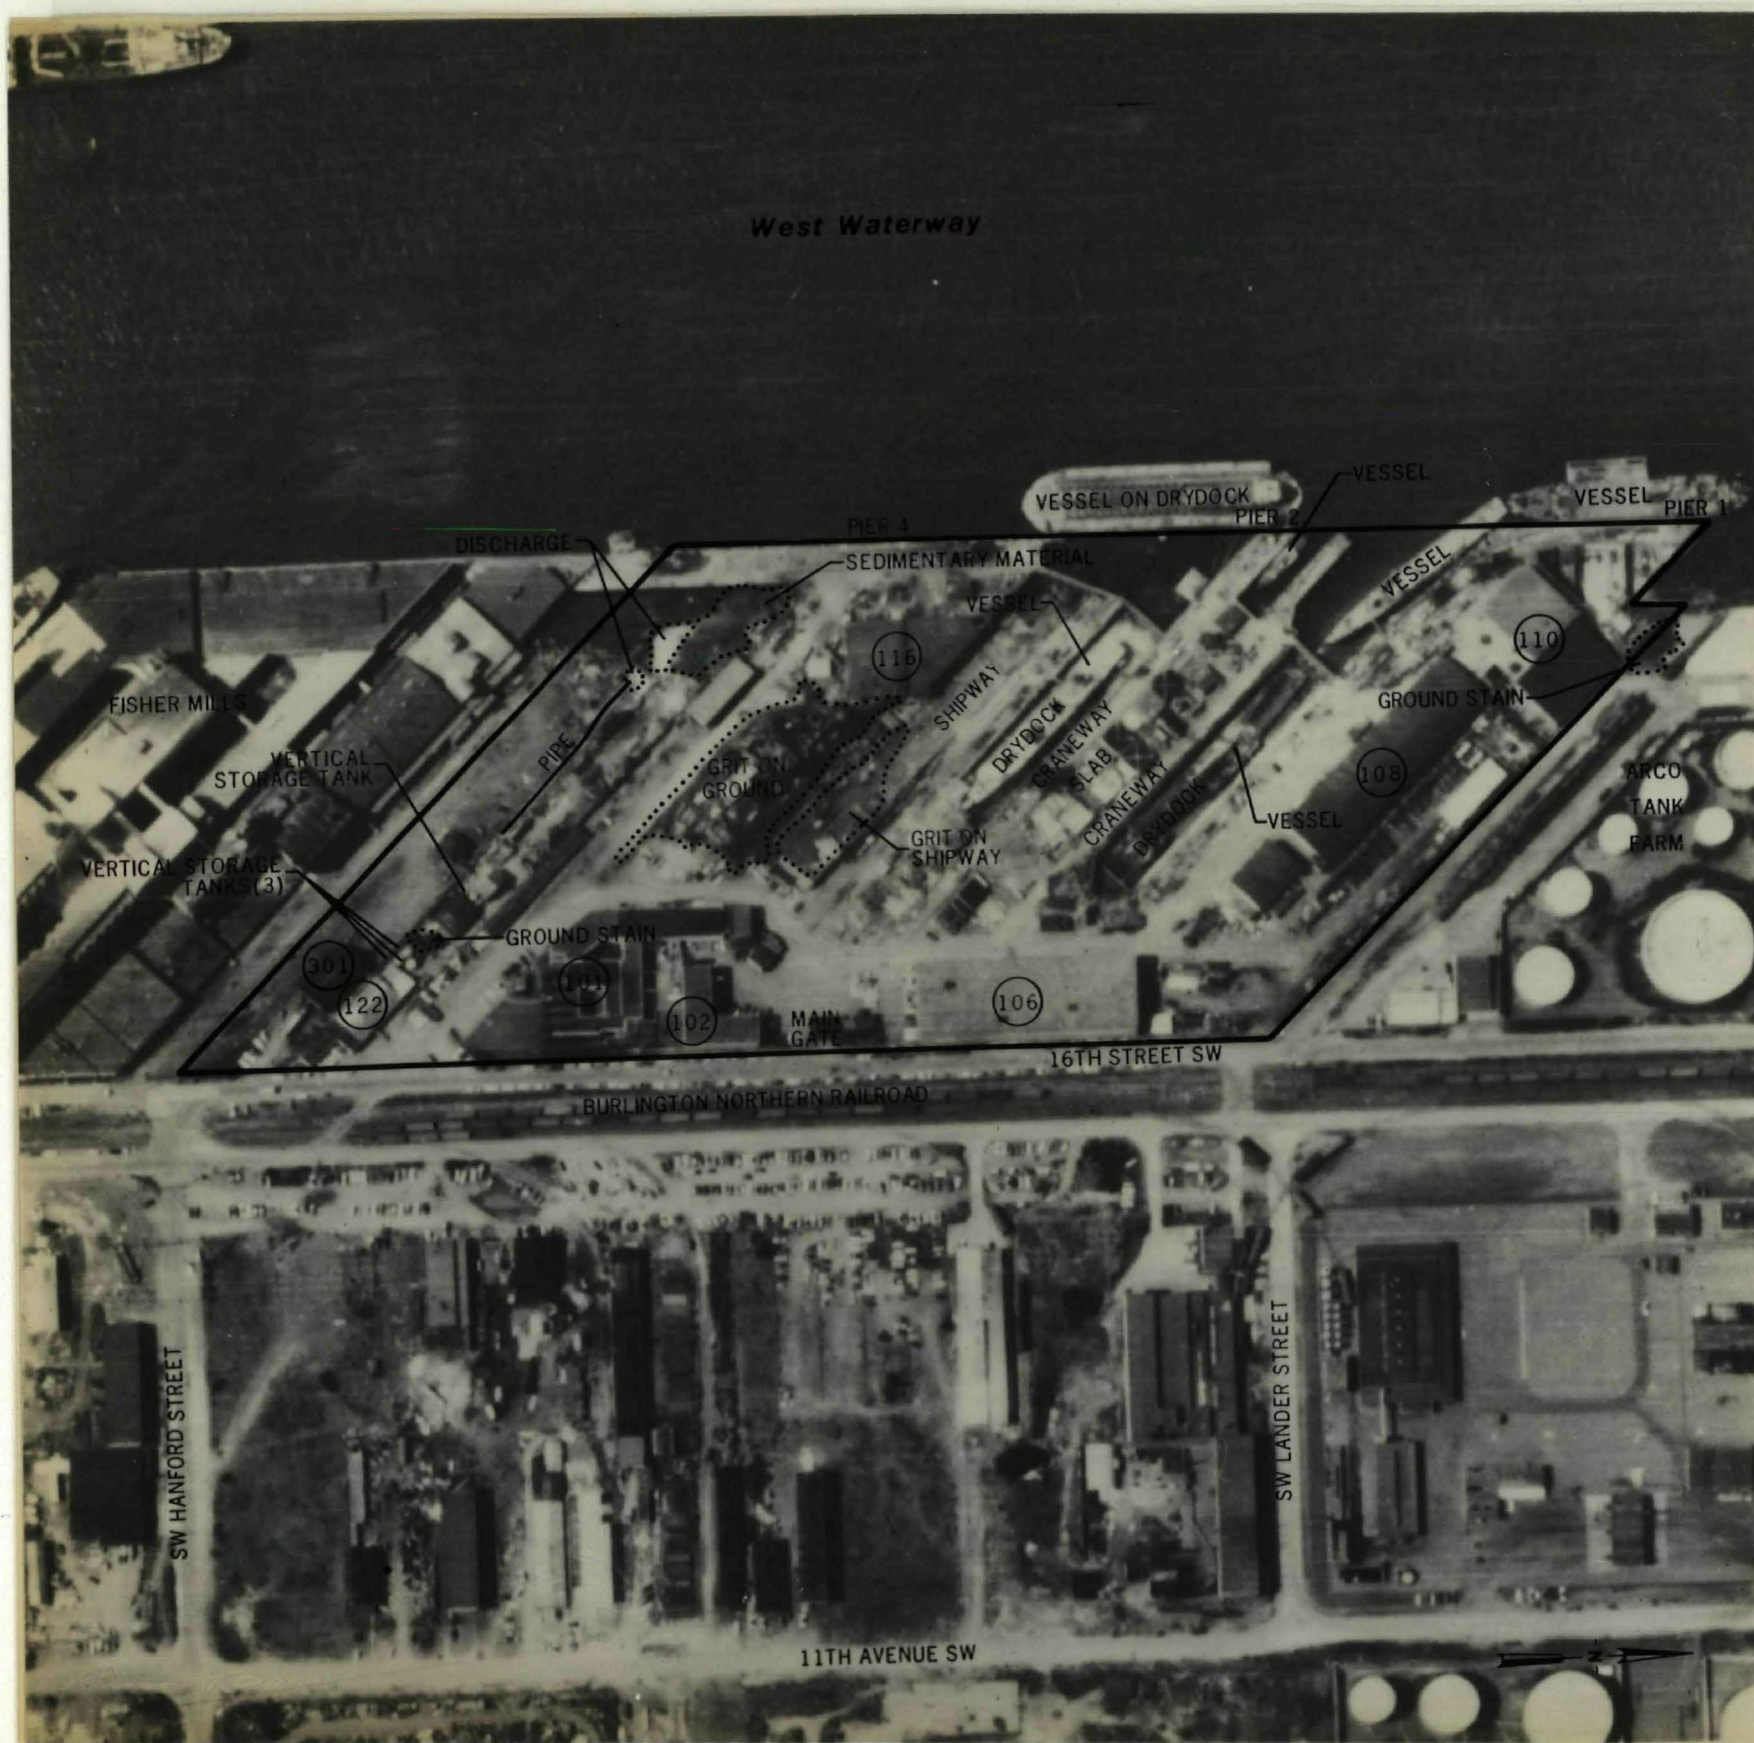
Photograph 7-3. Shipyard 1: August 8, 1956. Approximate Scale, 1 inch equals 265 feet.

Several sources of potential environmental contamination were noted across the site. Beginning along the south end of Yard 1 and moving north, the following were observed:

- ✓ Discharge from pipe - A whitish material is being discharged from a pipe or drainage line that appears to have its origin near a small building along the southern edge of the developed site. The discharge occurs on a low bank above the small water body impounded by Pier 4. Also associated with this water body is a sediment-like material piled along the banks, which partially fills the impounded area.
- ✓ Vertical storage tanks - Four tanks are located southeast of the pipe. A ground stain is associated with the cluster of three tanks.
- ✓ Sandblasting activity - What appears to be abrasive grit is spread across a portion of a shipway and heavily covers the ground immediately to the south.
- ✓ Ground stain - A heavily stained area is partially located on the Yard 1 property just north of Building 110.

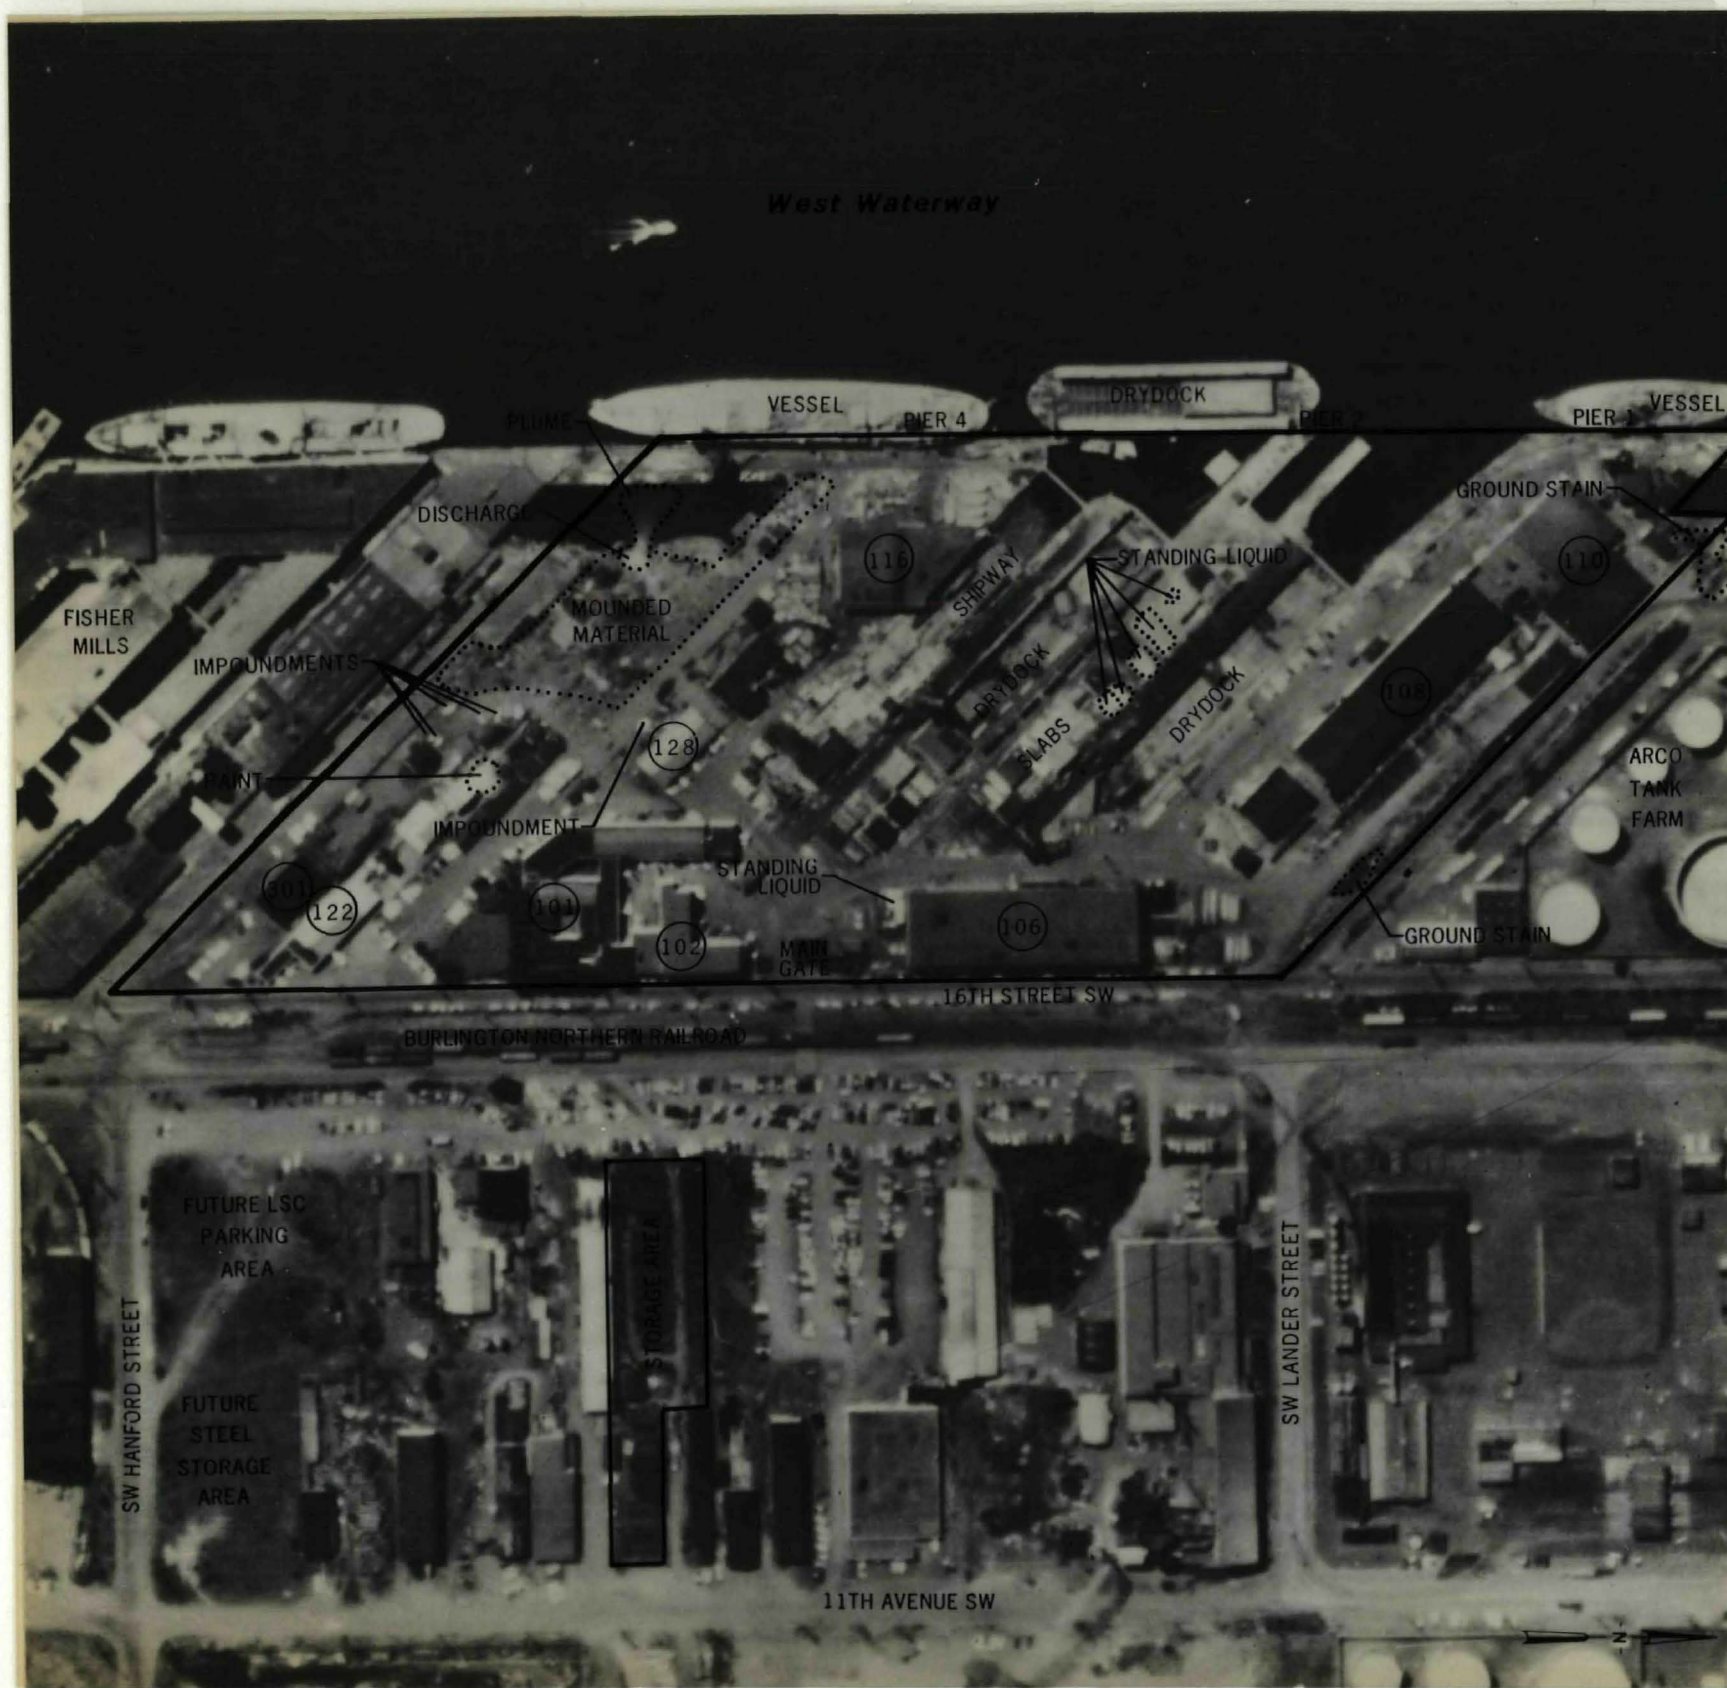
Photograph 7-4. Shipyard 1: June 23, 1960. Approximate Scale, 1 inch equals 250 feet.

✓ Discharge point - The discharge point observed in 1956 is still active at the south end of the property, although the above ground pipe from which the discharge emanated in 1956 is not visible. The location of the discharge point has not changed.

✓ Impoundments - Five small impoundments or ground depressions holding a whitish colored liquid are located along the south end of Yard 1. Another standing liquid area is located at the southwest corner of Building 106. This liquid is also very light-toned and appears to be held in place by a low berm. On the slab between the two dry docks are five additional areas of light-toned standing liquid that appears to be held or contained in some way.

✓ Paint - A paint deposit is located adjacent to a small building west of Building 122.

✓ Ground stains - Two areas of heavy ground staining are located along the northern edge of Yard 1.

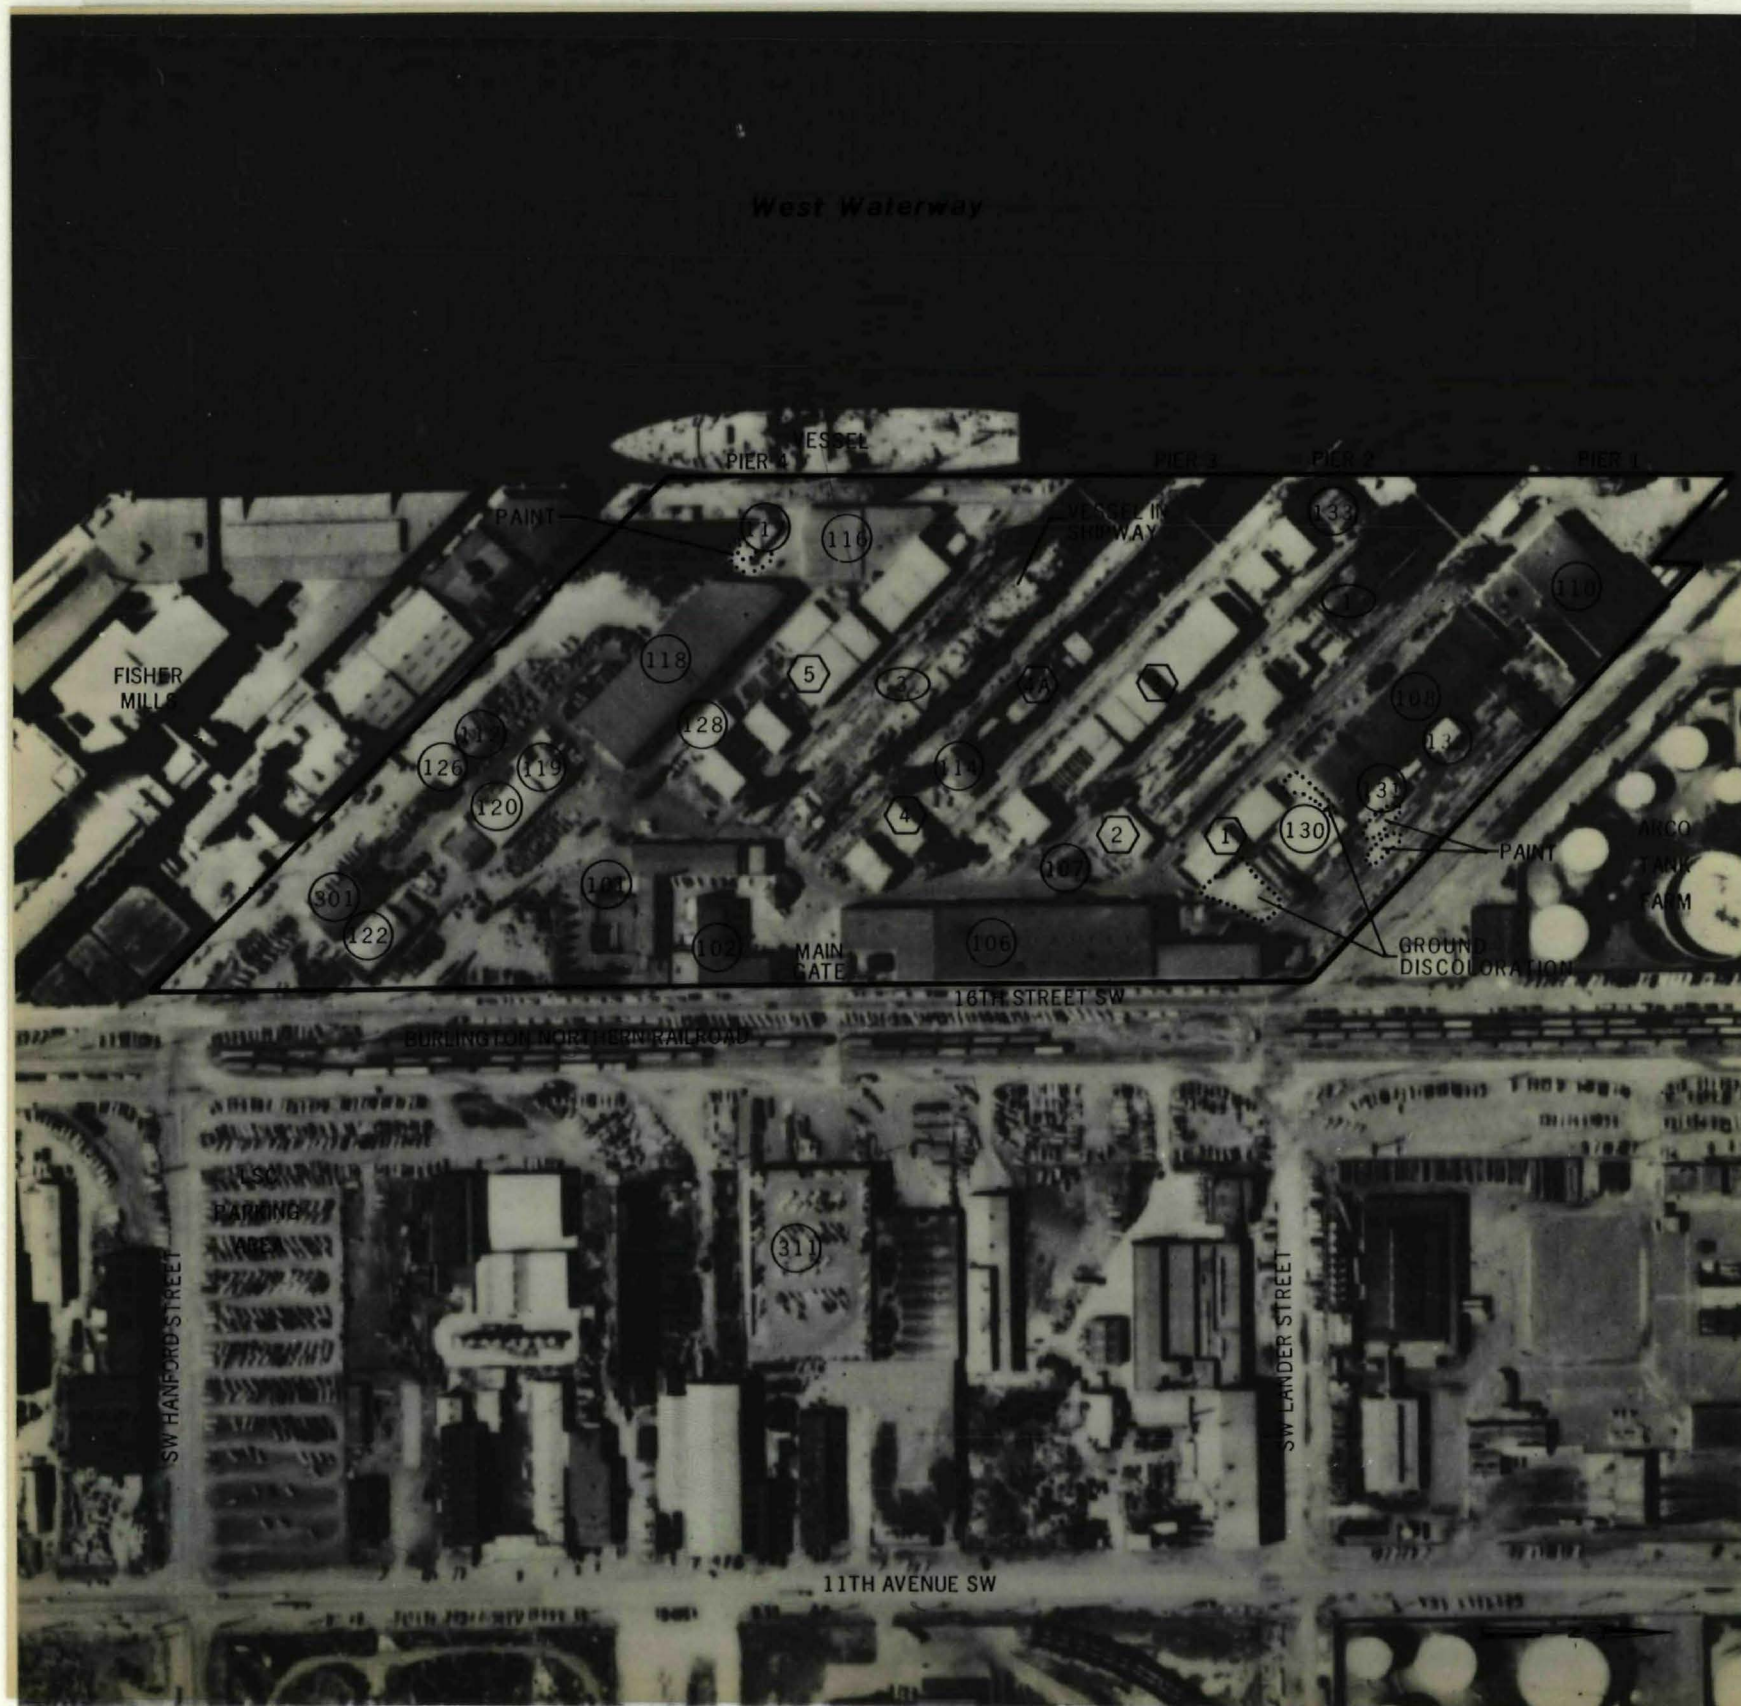
Photograph 7-5. Shipyard 1: March 25, 1969. Approximate Scale, 1 inch equals 265 feet.

Evidence of improper material handling includes:

- ✓ - A spill/ground stain east of Building 301
- ✓ - Extensive paint deposits on the ground around Buildings 131 and 117.
- ✓ - A whitish ground discoloration around Building 130 (original nature unknown).

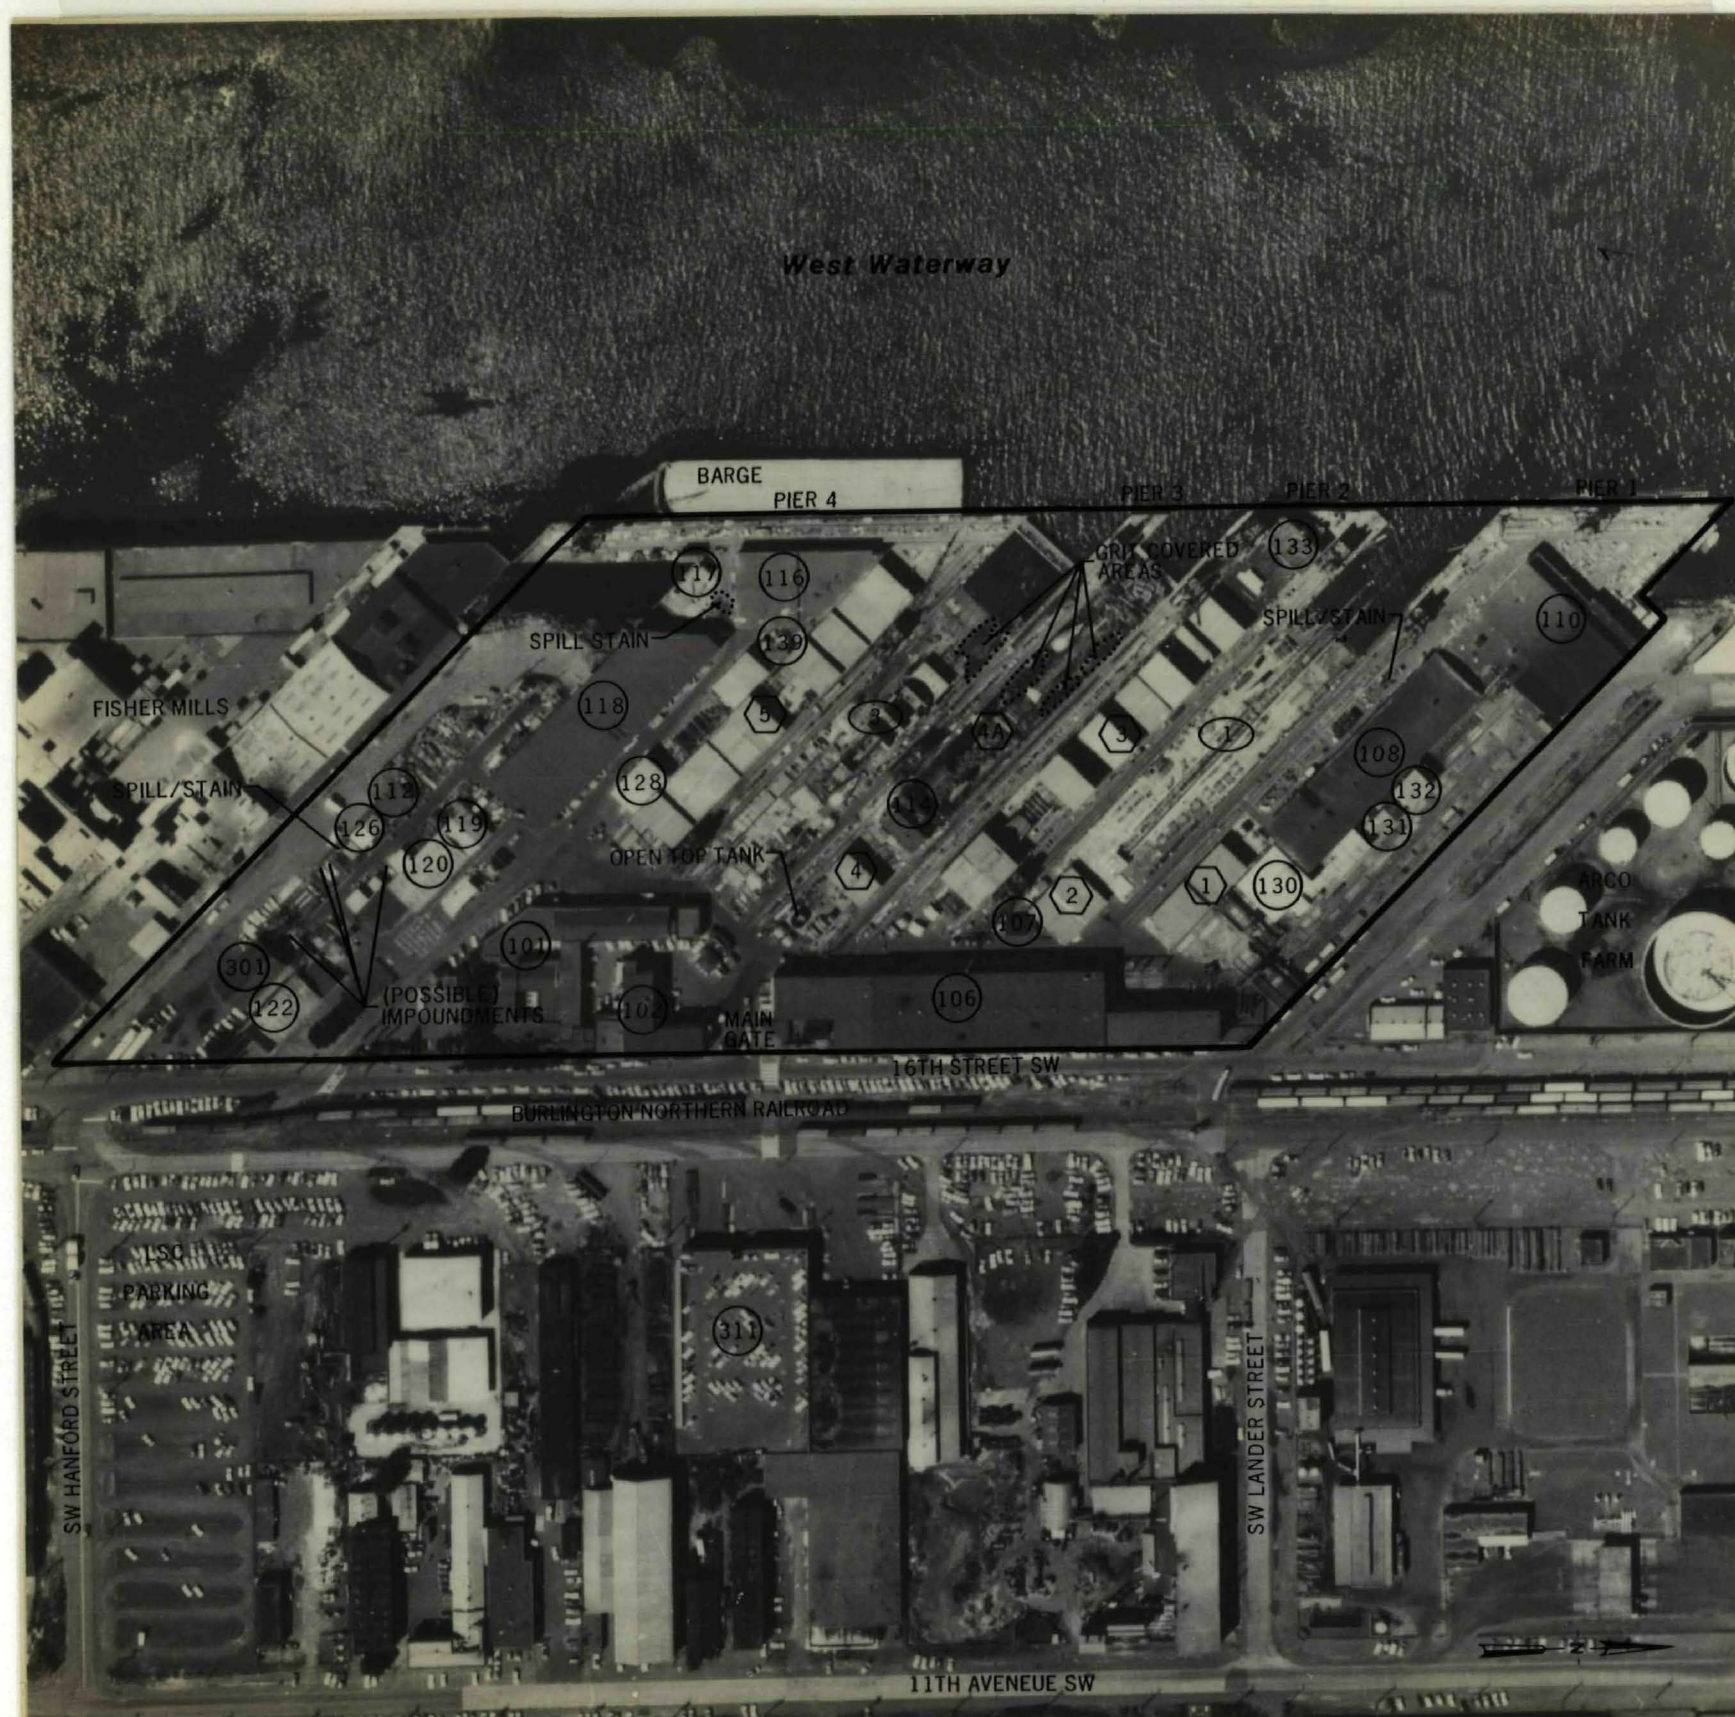
Photograph 7-6. Shipyard 1: August 10, 1970. Approximate Scale, 1 inch equals 250 feet.

There has been no major change in facilities development since 1969. Evidence of possible environmental contamination was observed in the following locations:

- ✓ Spills/ground stain - Two areas were observed. The first is east of Building 126 and the second is between Building 108 and Craneway 1.
- ✓ Abrasive grit deposits - Grit covered areas were observed on Shipway 3 and Slab 4A.
- ✓ Impoundments (possible) - Four small areas were observed near the south end of the facility that appear to impoundments or depressions containing a very light-toned liquid.
